CITY OF ARVIN

2019 SEWER MASTER PLAN

VOLUME 1 - REPORT

SEWER MASTER PLAN FOR THE CITY OF ARVIN

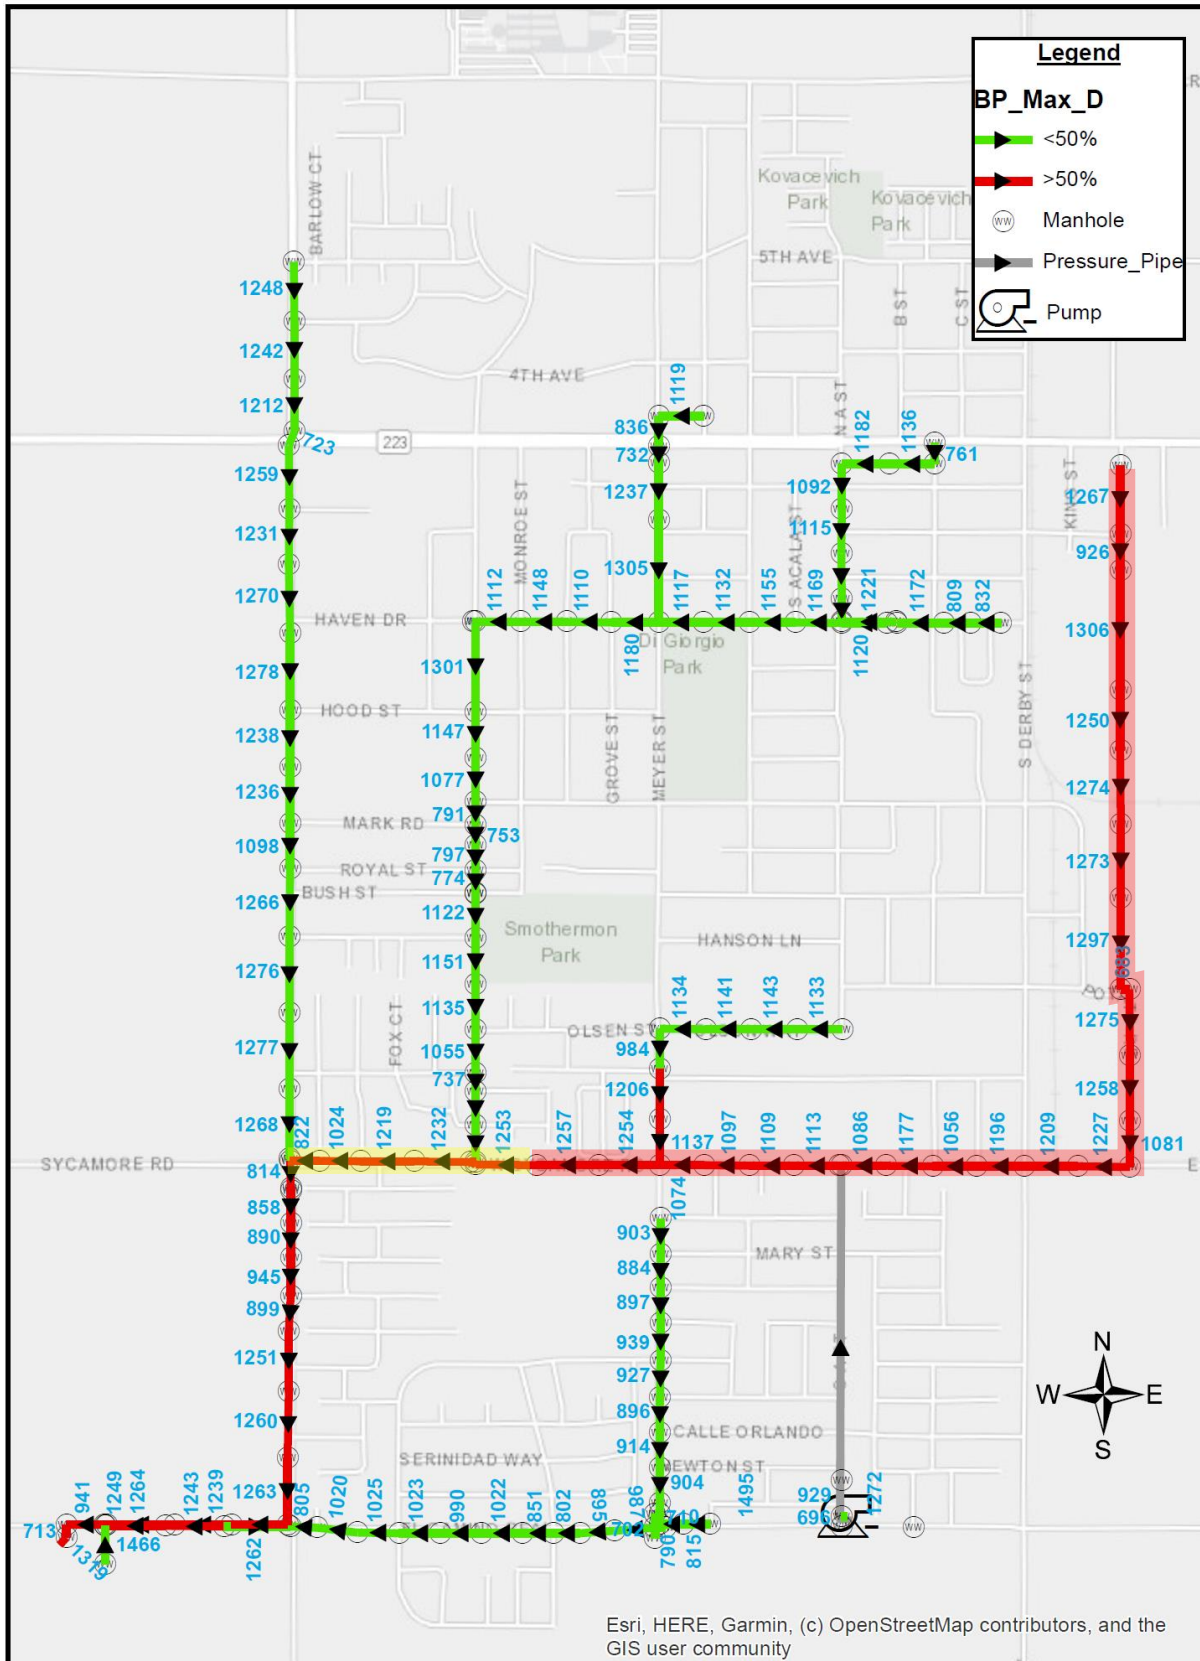
Figure 5.7 – Build-Out Peak Conditions: Depth to Diameter Ratio Constraint

Under build-out peak flow conditions, pipes that exceed the maximum depth to diameter ratio of 0.5 are shown in red. The maximum design capacity of a pipe 12 inches in diameter or less is half-full and the design capacity of a pipe greater than 12 inches in diameter is three-quarters-full. As pipes approach 100% full, the flow characteristics change from gravity flow to pressurized flow. Under pressurized flow conditions, (1) excess pressure weakens bends and joints in the pipelines causing pipe segments to leak or separate, and (2) excess flow tends to build up in manholes causing them to overflow.

28% of pipes exceed their design capacity. All of these pipes are located in Potato Road and Sycamore Road. The pipes highlighted in pink exceed 100% full, and the pipes highlighted in yellow are between 75% full and 100% full.

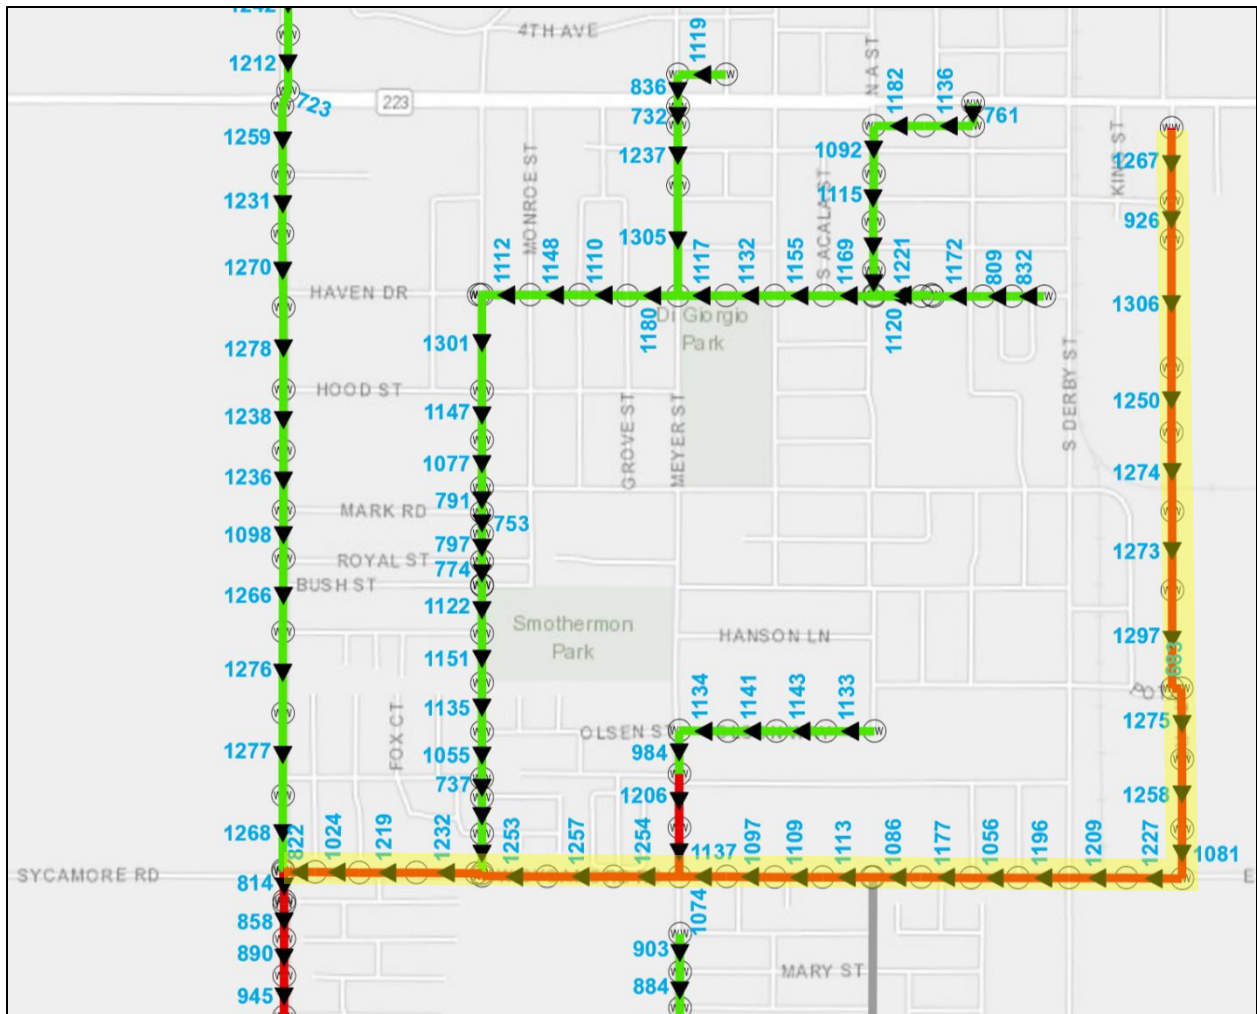
Figure 5.8 – Potato/Sycamore Alignment

All pipes in Potato Road and Sycamore Road were found to exceed the design depth to diameter ratio under build-out conditions (see the highlighted alignment in Figure 5.8). The primary reason for the design depth to diameter ratio exceedance is wastewater generation due to future development northeast of the intersection of Derby Street and Sycamore Road. Furthermore, the pipe in Sycamore Road between Walnut Drive and Comanche Drive is influenced by all future development north of Sycamore Road.

At build-out, development of the area designated for light industrial, heavy industrial and estate residential land uses located generally northeast of the intersection of Derby Street and Sycamore Road will generate wastewater at a rate that exceeds the capacity of the existing trunklines highlighted in Figure 5.8. We understand this area is not currently scheduled for development and is not anticipated for development within the next 20 years. In the event development of this area proceeds more quickly, additional study will be required to determine (1) the wastewater generation rates of the specific industries and residential densities to be included and (2) the best course of action for the City.

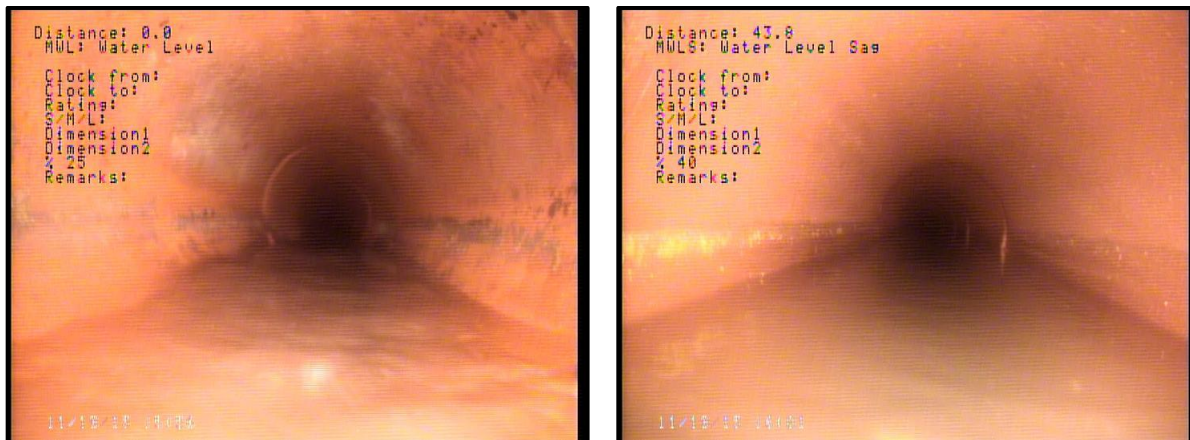
Figure 6.1 – Example of Pipe Recommended for Replacement

Figure 6.1 shows a view of the same pipe upstream and downstream of a sag. This pipe sag is located in Haven Drive east of Santa Rosa Street. The sag causes pipe velocity to slow and depth to increase at the low point of the sag interfering with normal flow. This pipe is vulnerable of exceeding the design depth to diameter ratio of 0.75 under peak condition making it susceptible to overflow.

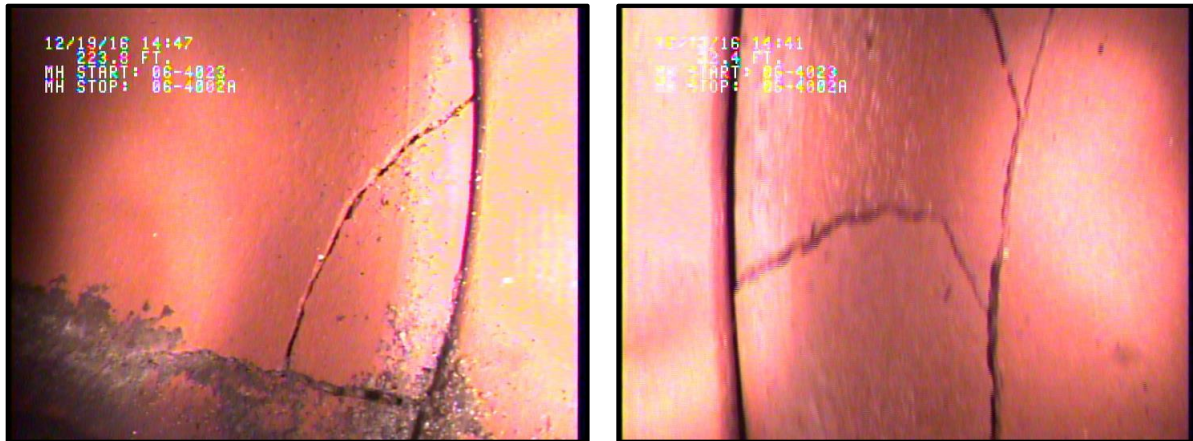
Figure 6.2 – Example of Pipe Recommended for Lining

Figure 6.2 shows two instances in the same pipe of cracking at the joint. The pipe also shows minor deterioration but no structural or alignment defect. This pipe is located in S. Hill Street immediately southwest of Di Giorgio Park. Lining will prevent continued cracking at the joints, which may otherwise lead to a collapse is not addressed.

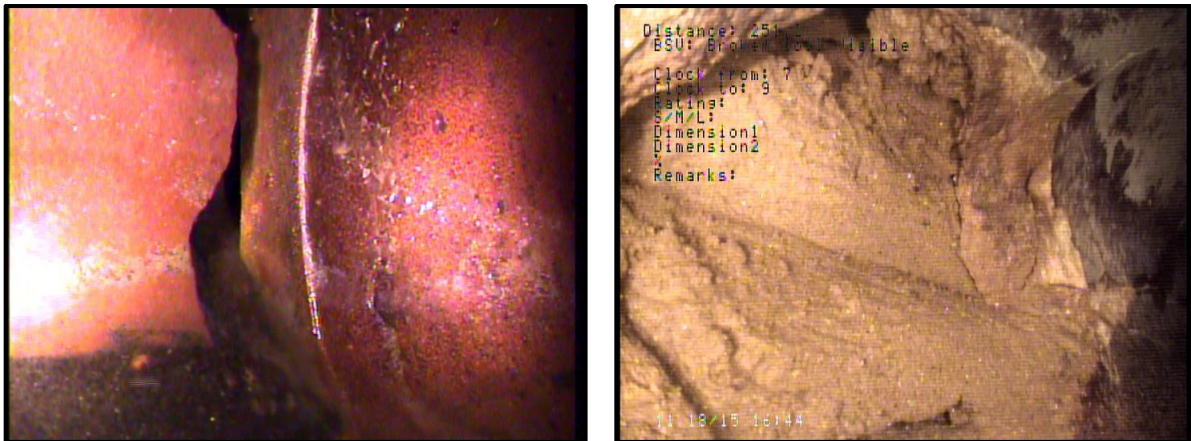
Figure 6.3 – Examples of Pipes Recommended for Spot Repair

Figure 6.3 shows two examples of broken pipes with soil entering the system. The pipe on the left is located in Monroe Street between Hood Street and Haven Drive. The pipe on the right is located in Monroe Street south of Big Bear Boulevard. Although the breaks are severe, they are localized so only a small repair is required.

Some pipes have localized defects such as cracks or root intrusion. If left unchecked, these defects may lead to more serious problems or even failures. Spot repair is recommended to address these localized defects while leaving the rest of the pipe alone.

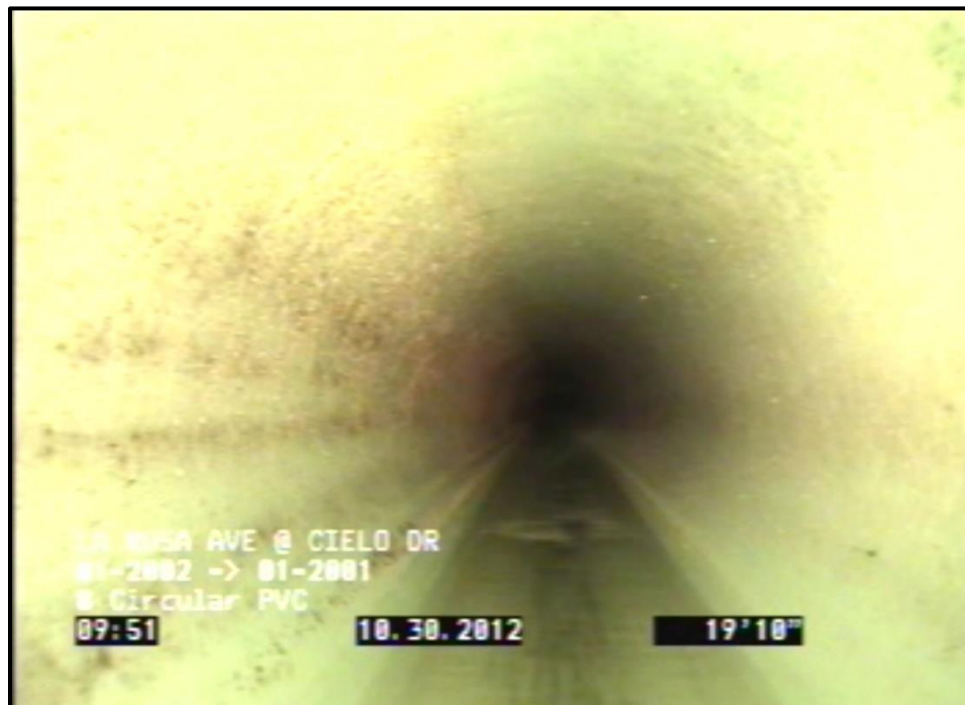
Figure 6.4 – Example of Pipe in Good Condition

Figure 6.4 shows a pipe in good condition with no visible defects and no sagging. This pipe is located in La Rosa Avenue west of Vista Avenue.

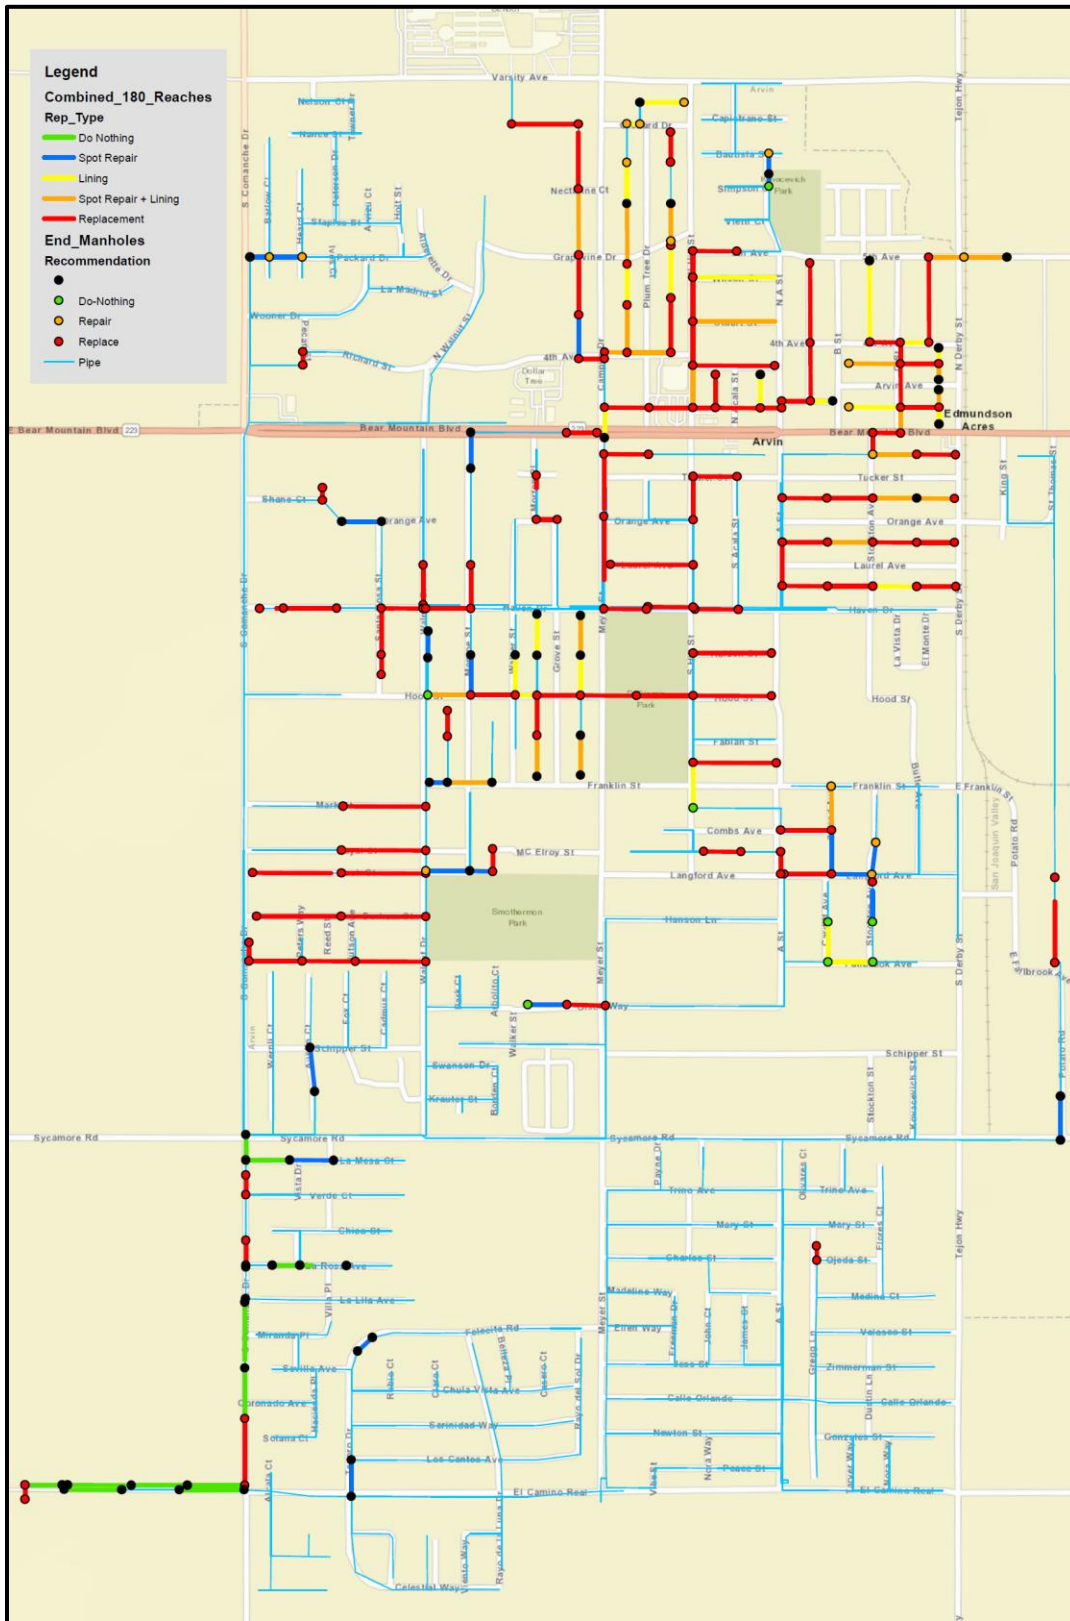
Figure 6.7 – Recommendations for Reviewed Pipes and Connecting Manholes

Figure 6.7 shows the location of the 180 reaches that were reviewed and the recommended course of action based on those reviews.

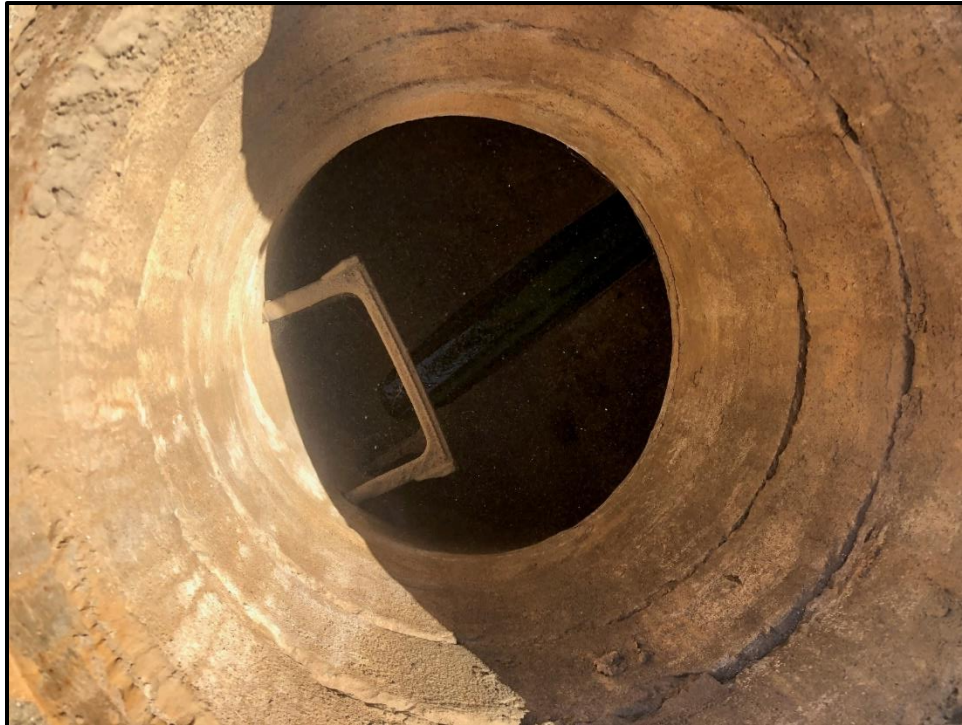
Figure 6.9 – Example of Manhole Recommended for Repair

Manholes that show deterioration or defects but are still structurally sound are candidates for repair. Figure 6.13 shows a manhole with a moderate deterioration.

Manhole repair is aimed at separating the sewer system from the environment in terms of eliminating ingress and egress. Water leaking into the manhole from outside may increase the load on the WRP, which impacts treatment efficiency. Wastewater leaking out of the manhole may adversely impact the local aquifer. Cracks, holes and gaps in joints between manhole components are filled with grout and coated with a sealant. If necessary, the soil surrounding the manhole is stabilized with engineered fill and the pavement surrounding the rim is replaced.

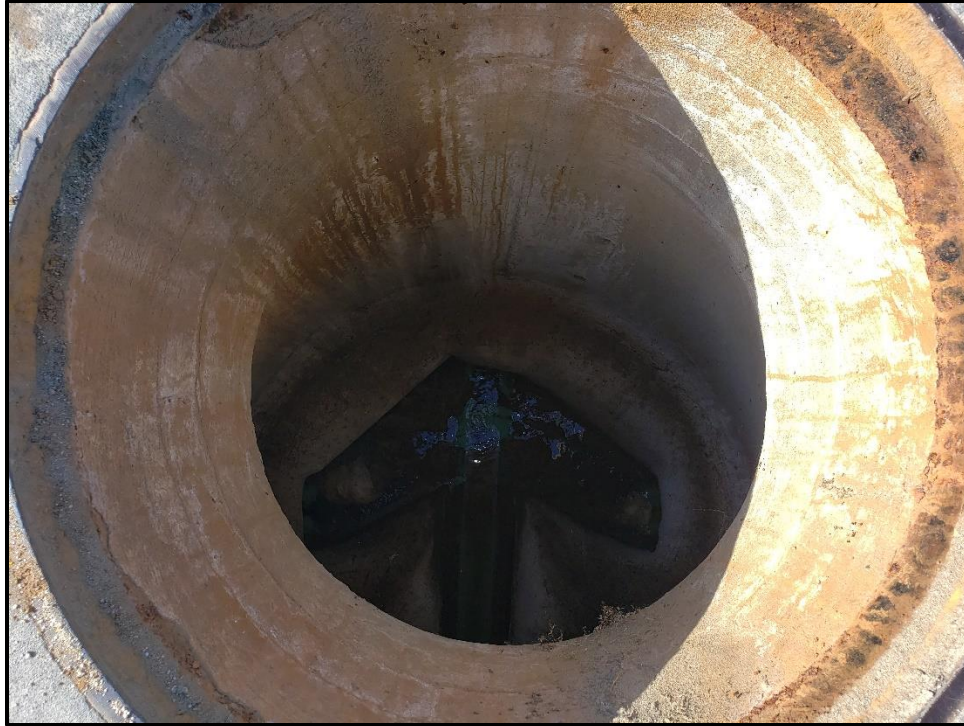
Figure 6.10 – Example of Manhole in Good Condition

Manholes that would not significantly benefit from repairs over the next 20 years are not recommended for mitigation. Figure 6.14 shows a manhole in good condition.

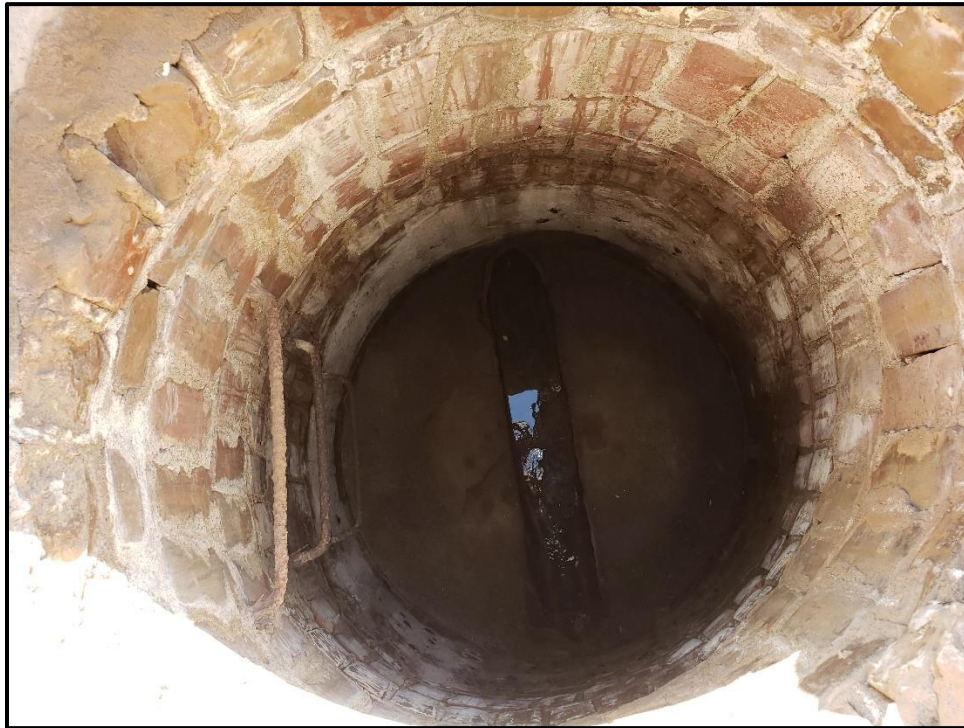
Figure 6.12 – Example of Manhole Recommended for Replacement

Manholes that have already failed or that exhibit structural damage are candidates for replacement. Replacement means the old manhole is removed and a new manhole is installed to take its place. Figure 6.12 shows one of the older brick construction manholes in the northeast portion of the City, which is recommended for replacement due to severe deterioration and compromised structural integrity.

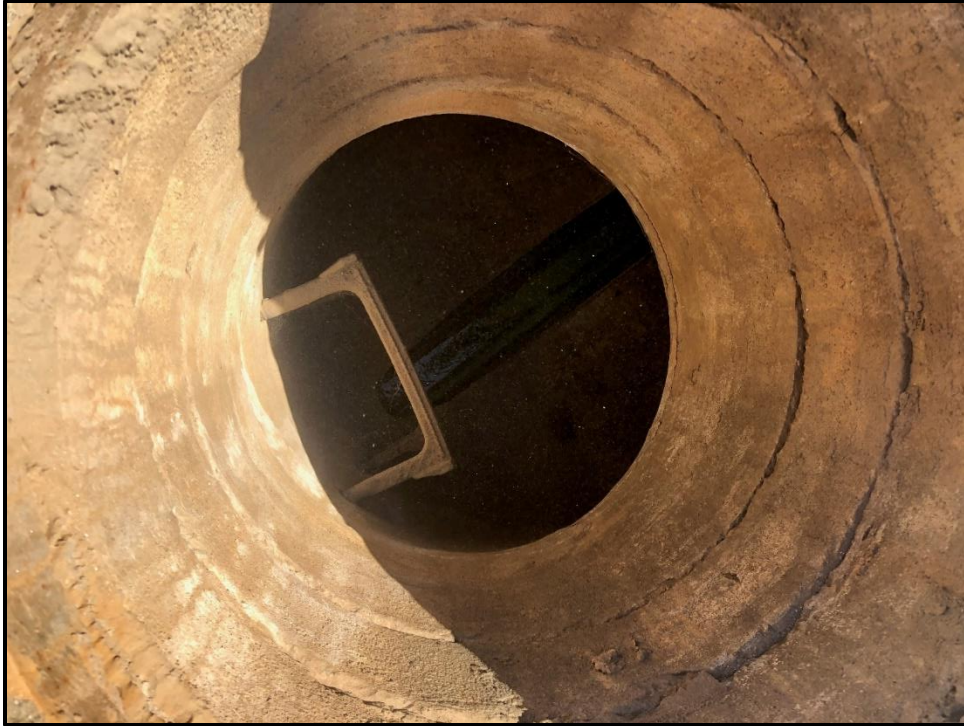
Figure 6.13 – Example of Manhole Recommended for Repair

Manholes that show deterioration or defects but are still structurally sound are candidates for repair. Figure 6.13 shows a manhole with a moderate deterioration.

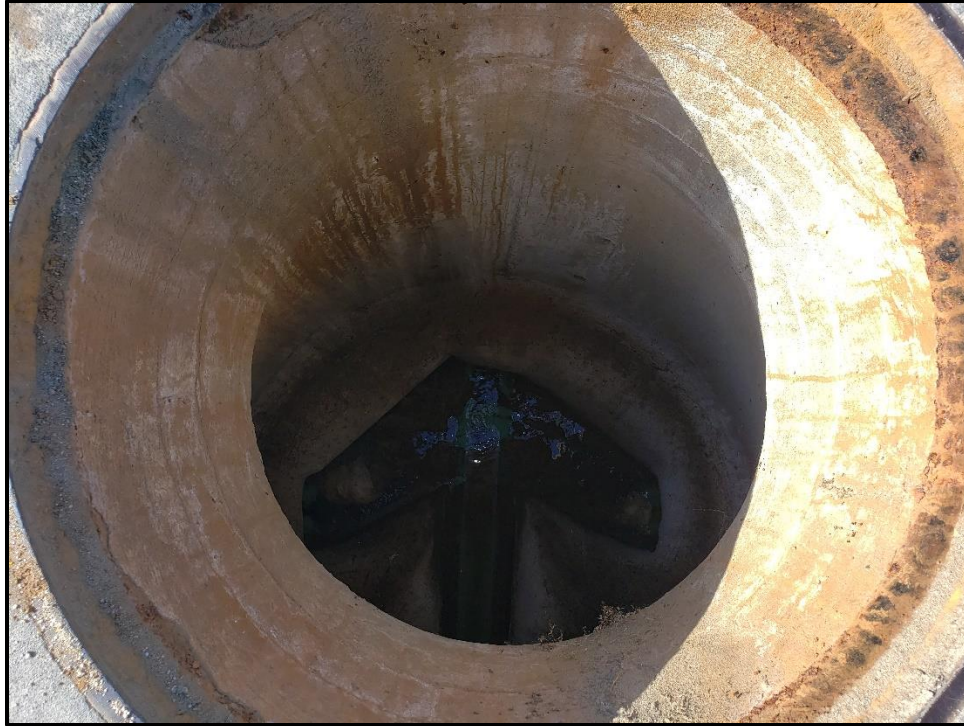
Figure 6.14 – Example of Manhole in Good Condition

Manholes that would not significantly benefit from repairs over the next 20 years are not recommended for mitigation. Figure 6.14 shows a manhole in good condition.
