PRIMARY RECORD

- P1. Other Identifier:** 620 First Street
***P2. .Location: *a. County** Solano
b. Address: 620 First Street
***c. City:** Benicia **Zip** 94510
d. UTM: N/A
e. USGS Quad: Benicia T2N R3W MDM
***f. Other Locational Data (APN #):** 89-342-24

BUILDING, STRUCTURE, AND OBJECT RECORD

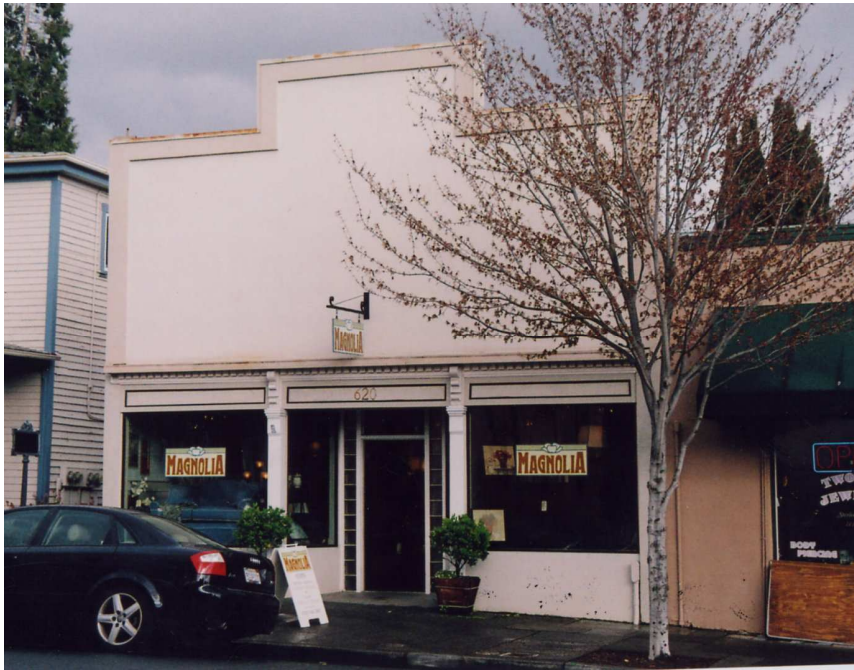
P5. Photograph or Drawing (Photograph required for buildings, structures, and objects.)

This is a rectangular plan front gable commercial building with a faux front. The building is of frame construction with a moderately pitched gable roof with only a slight eave overhang. The gable end is hidden by a false front stepped pediment intended to give the building a more imposing street presence. A recessed central entry is flanked by storefront windows. The entry is elaborated with pilasters at the edge of windows. An elaborated dentil cornice extends across the front elevation just above the entry and windows. The sides and rear of the building are clad with clapboard siding which is probably original. The front elevation has been covered with stucco..

P5b. Description of Photo: Front and north façade, view southeast

The building has the massing, form and basic features of a typical commercial/retail establishment from late 19th or early 20th century Benicia. The integrity of the building's location, setting and association remains intact. However, the refinishing of the front elevation has had a substantial impact on the integrity of the building's materials and workmanship. Because the alterations are to the front façade, the most important elevation in a building of this type, the store front no longer retains sufficient integrity for listing as a contributor in the Downtown Historic District. Since the original elements of the building appear to remain under the alterations, the building might qualify for listing if it was rehabilitated.
