PRIMARY RECORD

*Resource Name or #: 905 First Street

b. Address: 905 First Street

BUILDING, STRUCTURE, AND OBJECT RECORD

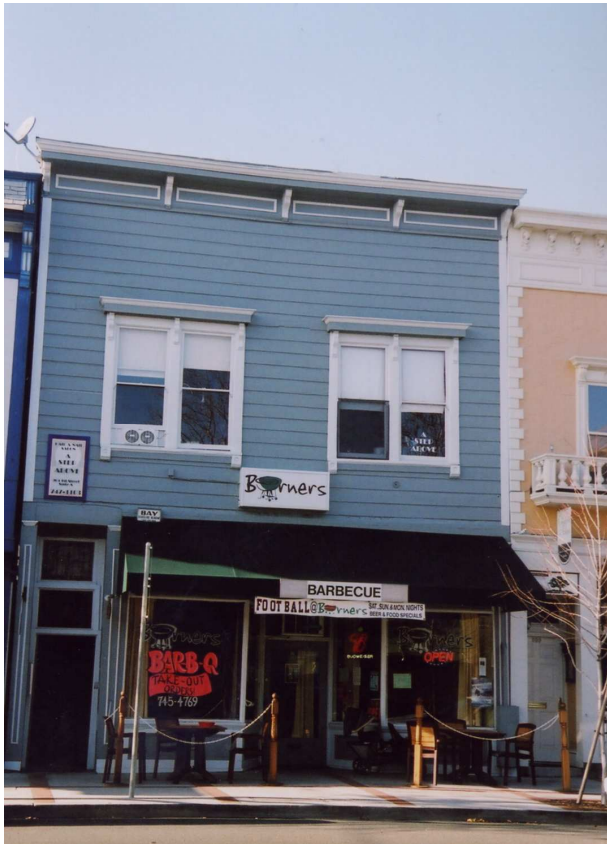
P5b. Description of Photo:

This is a two-story Italianate store front building. It has a false front with a pediment supported on brackets. It has a paneled cornice. Upper story windows are paired one-over-one double hung with bracketed pediments and sills. At the first floor level a typical store front occupies most of the north side of the façade while an entry to the second story is found on the south side. The storefront has a central door with canted store front windows. The second story entry is slightly recessed and has a transom. The building is clad with clapboard. It is one of four contiguous buildings from the late 19th century that remain in the block and provide a strong feeling of a 19th century commercial street front.

Front façade, view west

The building retains most of its character defining features including its false front parapet, elaborate cornice, fenestration, and store front with a separate side entrance. The building has integrity of materials, design, workmanship, setting and location. Its significance is enhanced by the fact that it is part of a continuous block of surviving 19th century commercial buildings. It contributes to the Downtown Historic District and should continue to enjoy that status.
