PRIMARY RECORD

*Resource Name or #: 242, 244, 248 West H Street

BUILDING, STRUCTURE, AND OBJECT RECORD

*Resource Identifier: 242, 244, 248 West H Street *NRHP Status Code: 3D

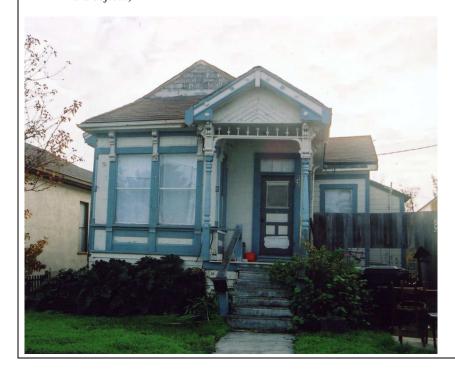
P5. Photograph or Drawing (Photograph required for buildings, structures, and objects.)

This house is a fine example of a workingman's Queen Anne Cottage. Despite its small size, it exhibits an array of decorative elements drawn from the Queen Anne vocabulary. The house is L-shape in plan with a gable-on-hip and cross gable roof. There also is a side shed roof addition on the west of the rear cross wing. The roof has wide overhanging closed eaves which are supported on molded brackets. A small porch is located on the west side of the house which is covered by a projecting gable which displays an elaborate fascia, stick and spindle work. The porch roof is supported on turned posts with brackets at the top. The brackets, which match those at the eaves, are used to visually unify the posts, gable end and facia. Prominent paired one-over-one windows dominate the east side of the front elevation. The eave brackets extend to the top portion of the window casings. The sills are supported on simple brackets which extend below the windows to the belt course and the wall under the windows has applied rectangular panels. Portions of the porch have been replaced. The house is clad with clapboard. This house is very similar to the adjacent cottage at 248 West H Street. The two houses, which share a single parcel, were probably built by the same builder.

P5b.	Description of Photo: Front façade
	view south

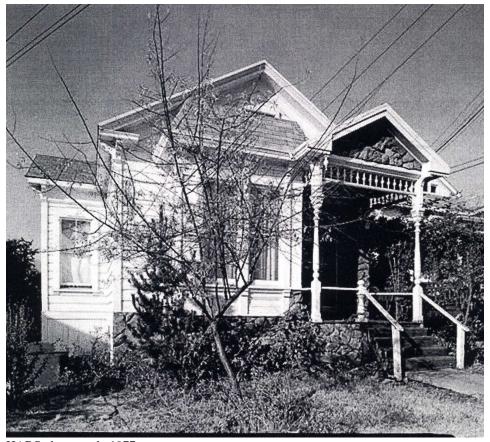
***B6. Construction History:** There have been alterations to the porch floor and stair. When the building was recorded by HABS in 1977 the foundation and the gable end had been covered with faux rock veneer. This has been removed and appropriate finishes have been applied to these areas.

HABS photograph 1977
