CITY OF ARVIN

2019 SEWER MASTER PLAN

VOLUME 1 - REPORT

SEWER MASTER PLAN FOR THE CITY OF ARVIN

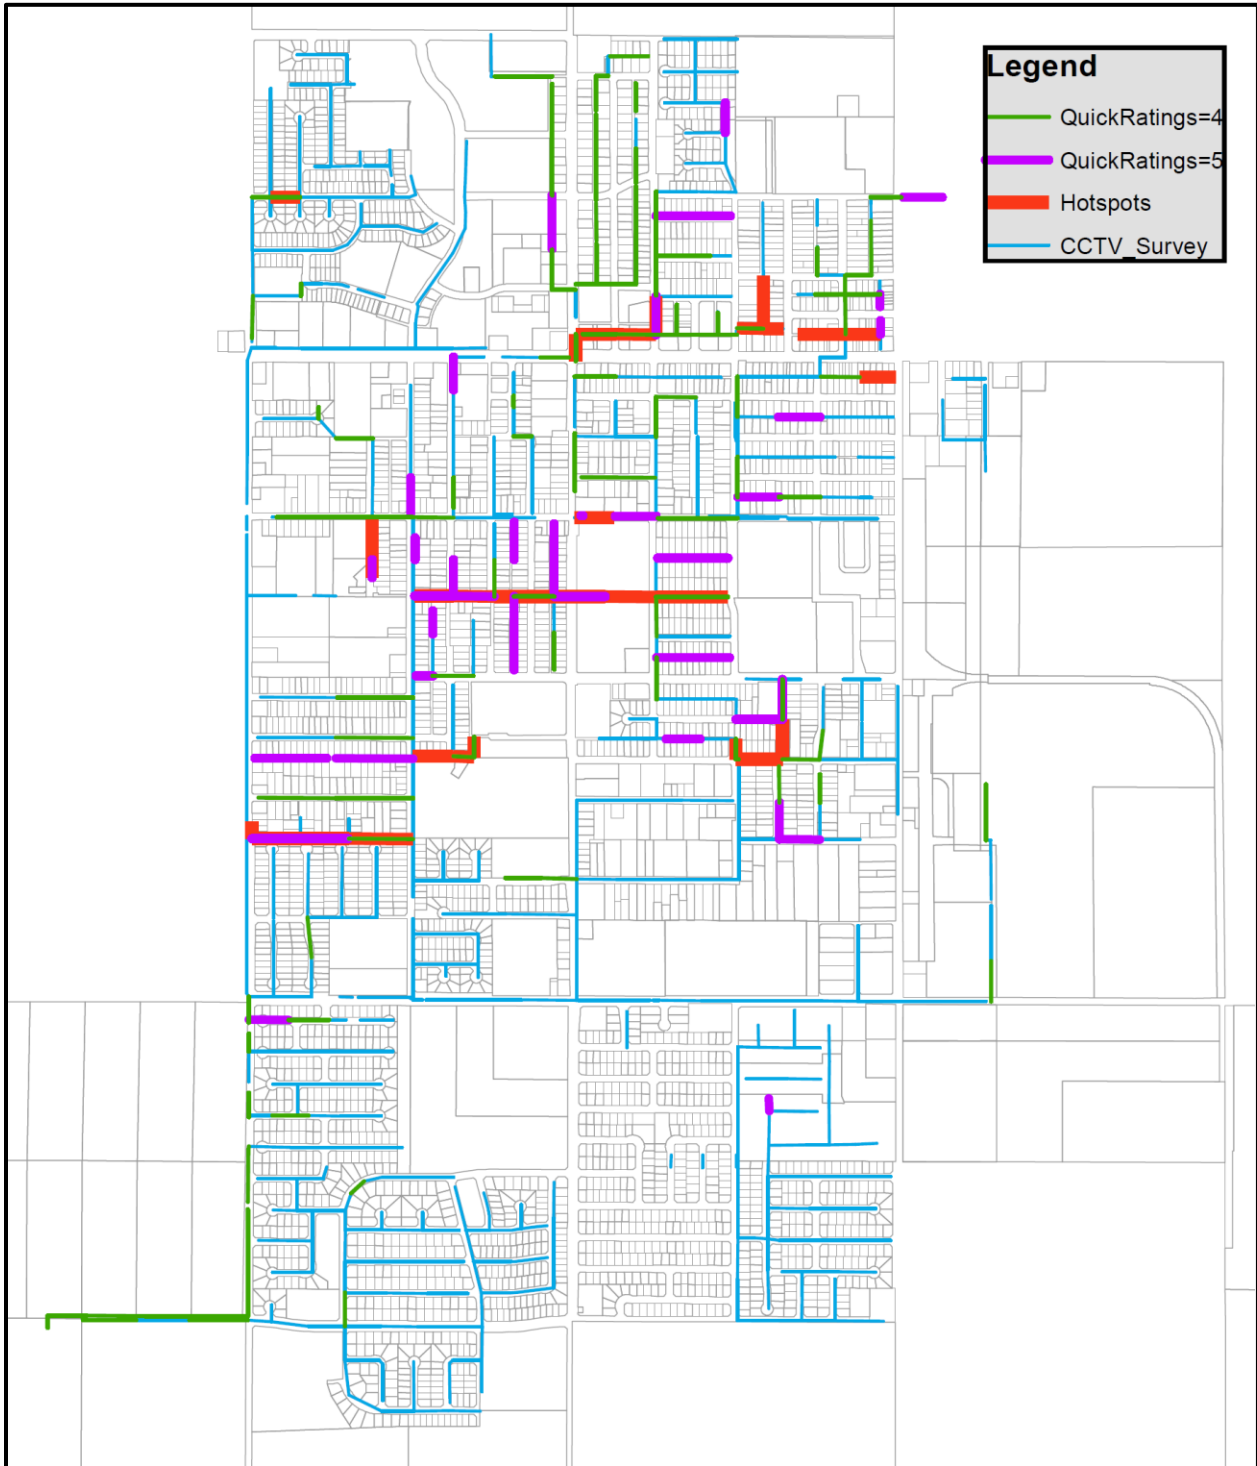
Figure 6.5 – Hot Spots and Quick Ratings

¹⁰ Quick Rating is a scoring system developed by NASSCO to indicate the severity of a defect found via CCTV. A rating of 5 indicates a defect recommended for mitigation within 5 years, and a rating of 4 indicates a defect recommended for mitigation within 10 years.

Not surprisingly, there is significant overlap between the Hot Spots and the Quick Ratings.

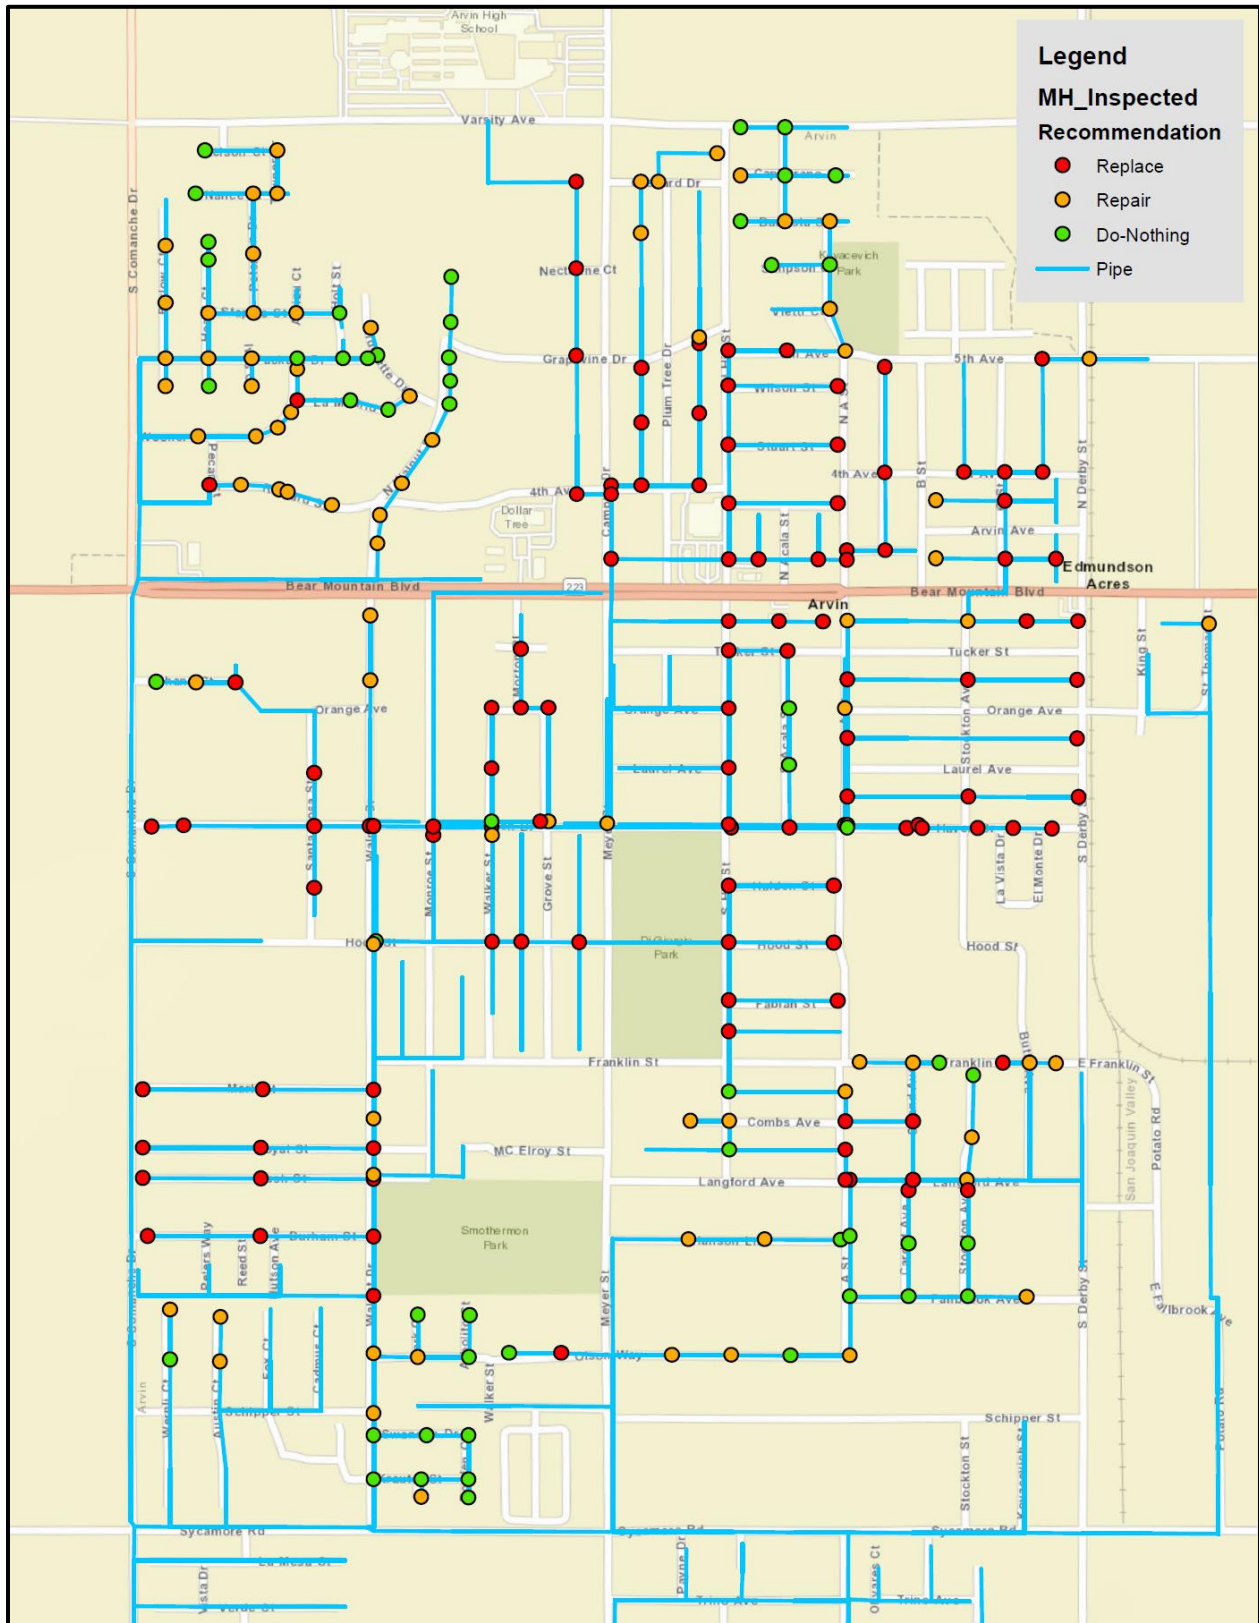
Figure 6.11 – Results of Manhole Inspections

Figure 6.11 provides a map of the manhole inspection and the recommendation for each.

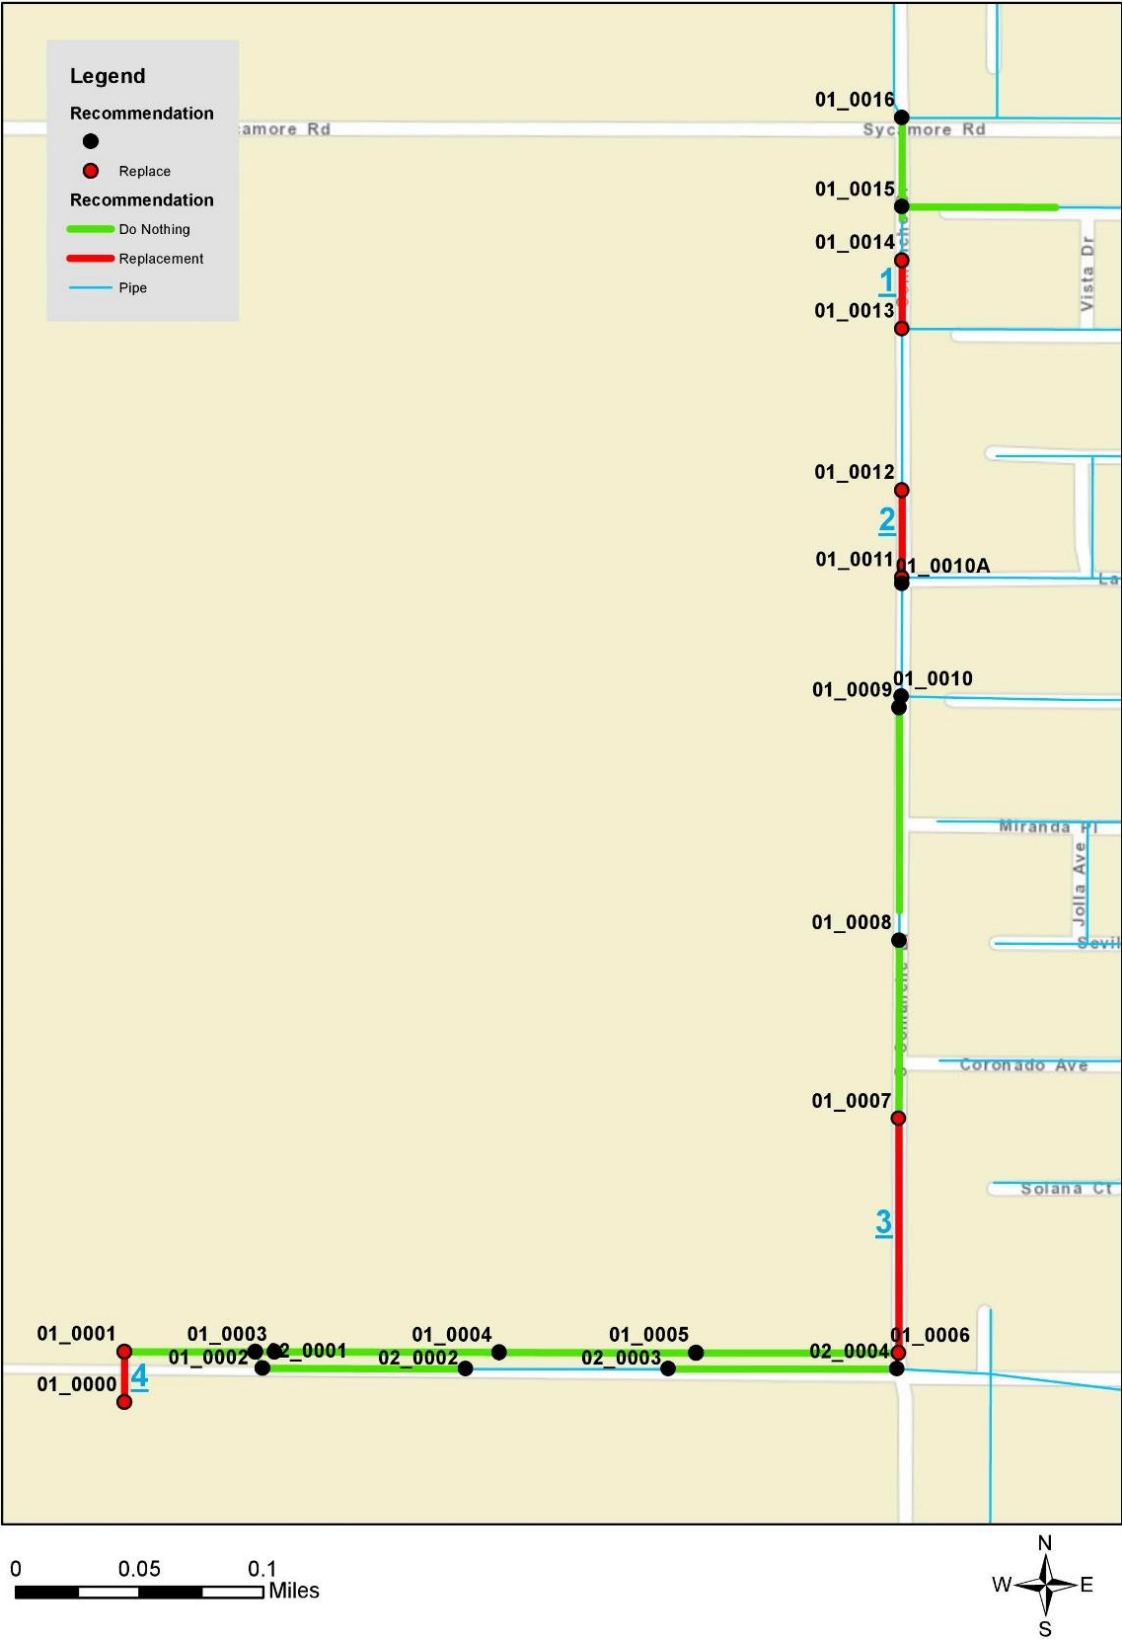
Figure 7.1 – Extent of Comanche Drive Pipeline Project

Table 7.7 identifies project-related reaches by number and manholes by designation. A reach is a portion of a pipeline between two consecutive manholes. Reaches are labeled in blue and manholes are labeled in black in Figure 7.1. Additional materials concerning project-related reaches and manholes are provided in Appendix O.

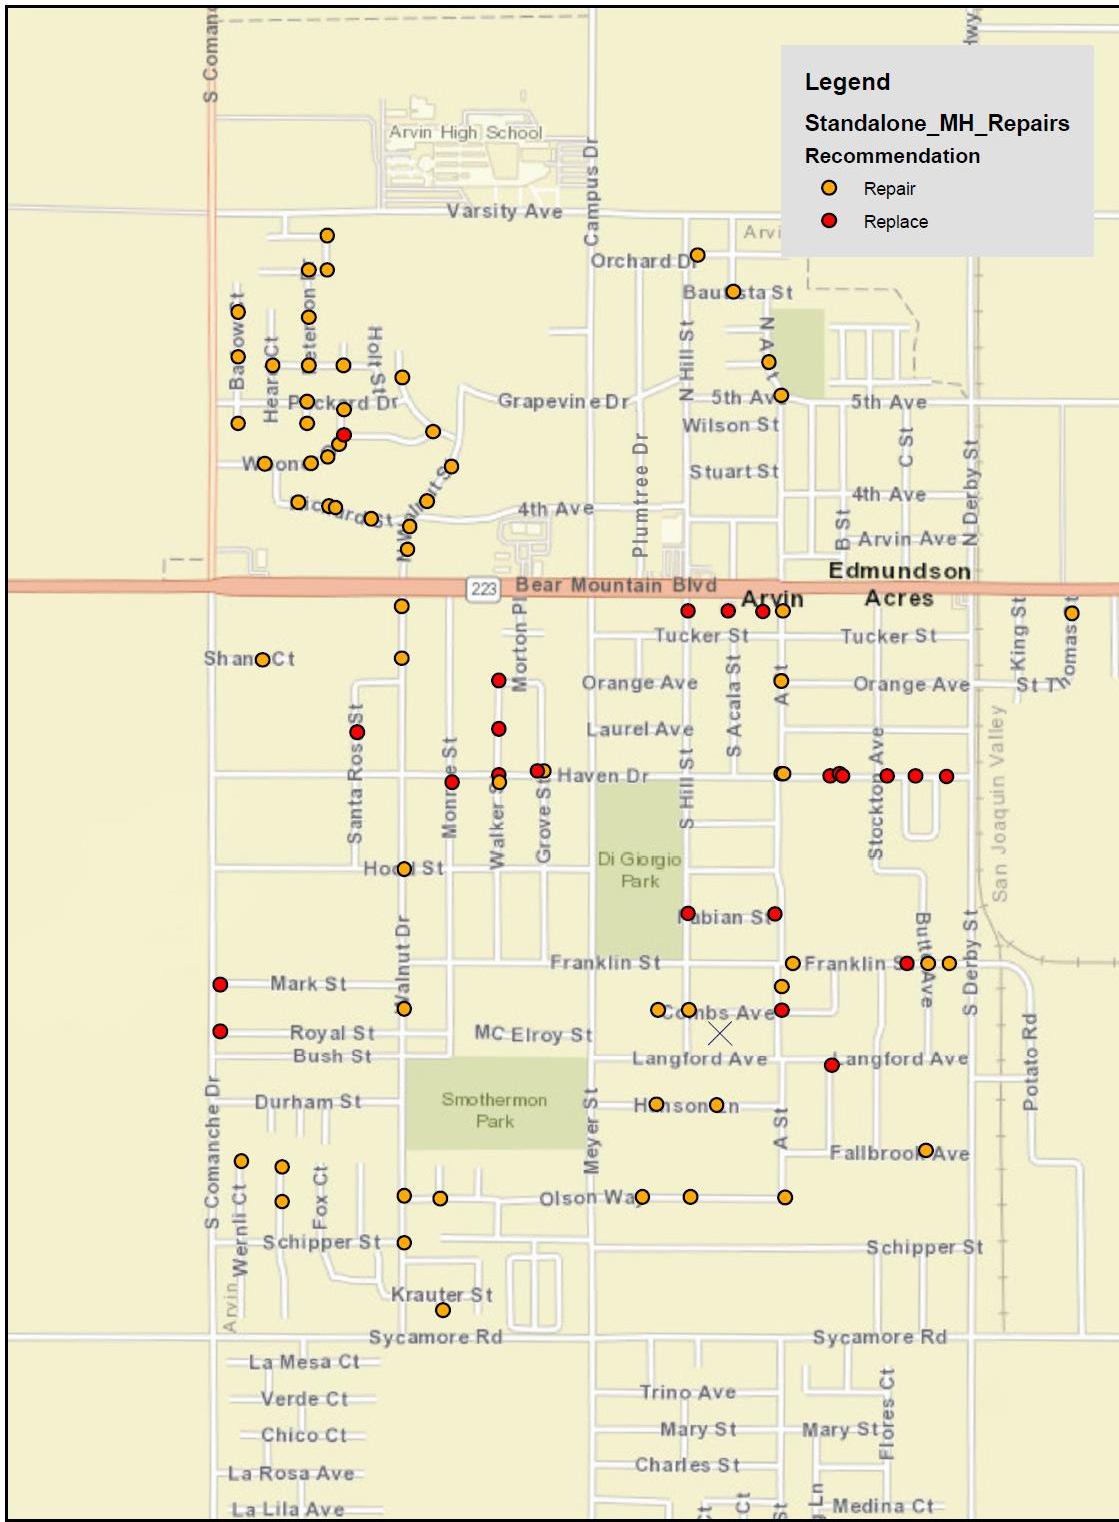
Figure 7.17 – Extent of Stand-Alone Manholes

This is a low priority project.
